HISTORIC STRUCTURE REPORT

THE MATTHEWIS PERSEN HOUSE

A Case Study of the History of a House and the People who Lived There

Kenneth Hewes Barricklo Architect, P.C.
Kingston, New York

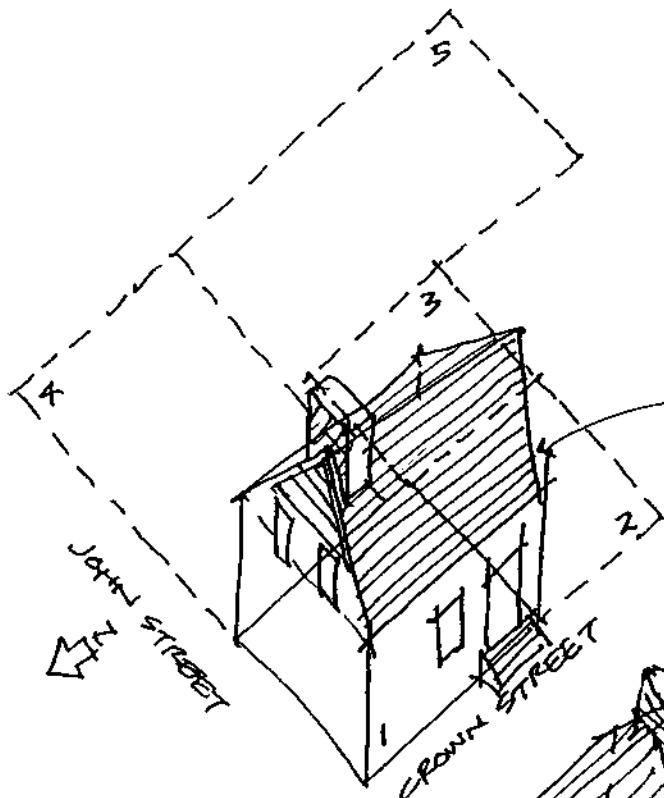
Pre-Phase One Conjectural
pre-1669

1/2 STORY STONE
STRUCTURE BUILT
POSSIBLY ON EARLIER
STONE FOUNDATION.
CHIMNEY BUILT LATER
ON NORTH WALL.

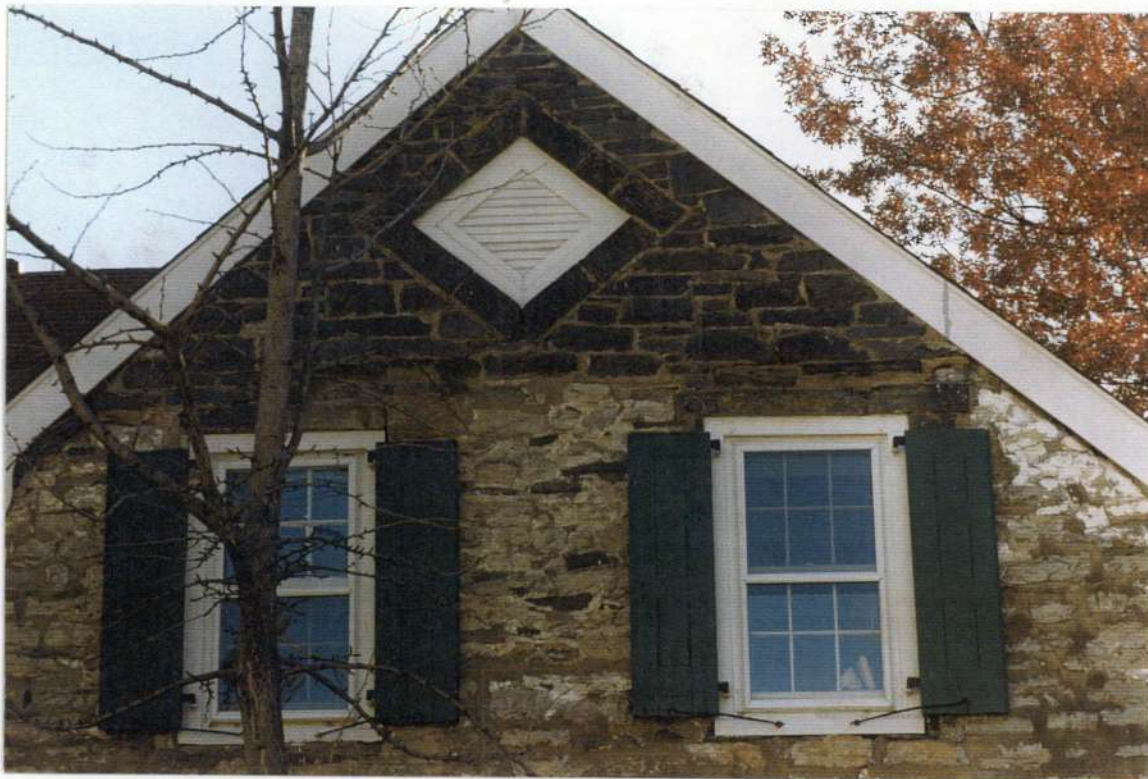
24. John Street gable end wall where darker stone replaced earlier wood gable end in ca. 1850s gothic revival period. Windows enlarged. Diamond detail added. Chimney removed. Dark stone was whitewashed to match earlier stonework.

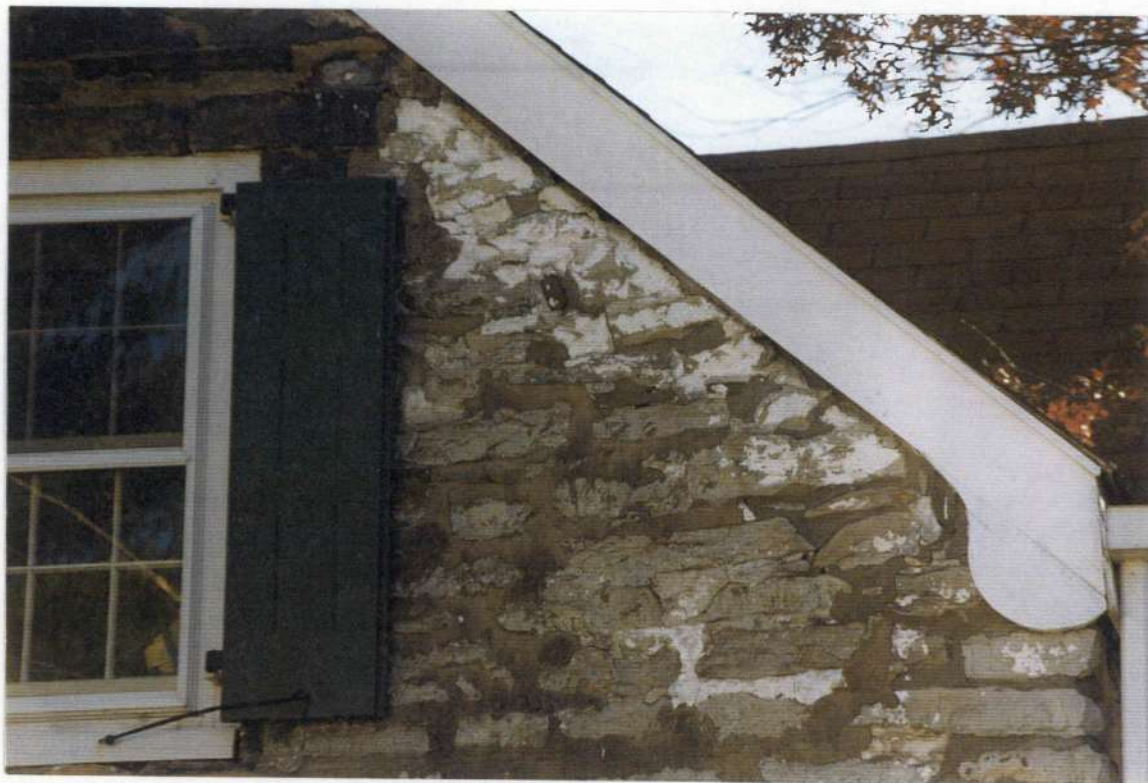
25. Detail: ca. 1970s cornice removed leaving pre-1850s whitewash.

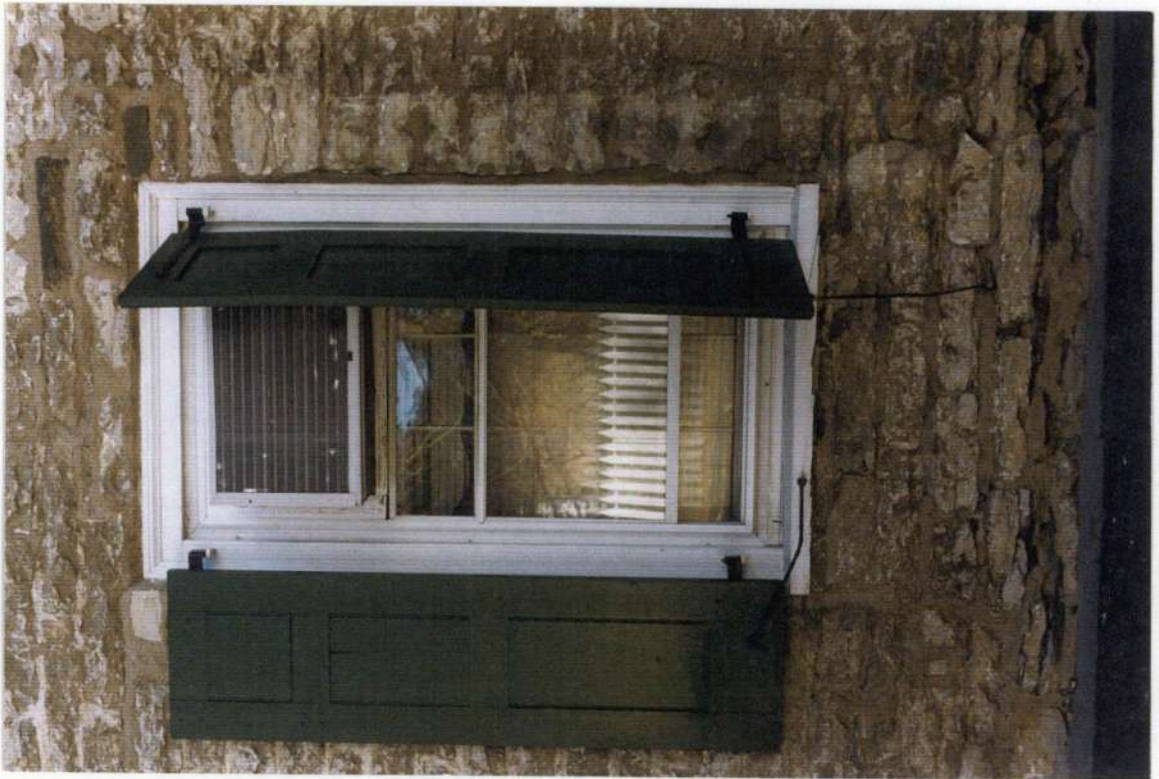
29. Typical replacement window and shutters and aluminum storm windows.

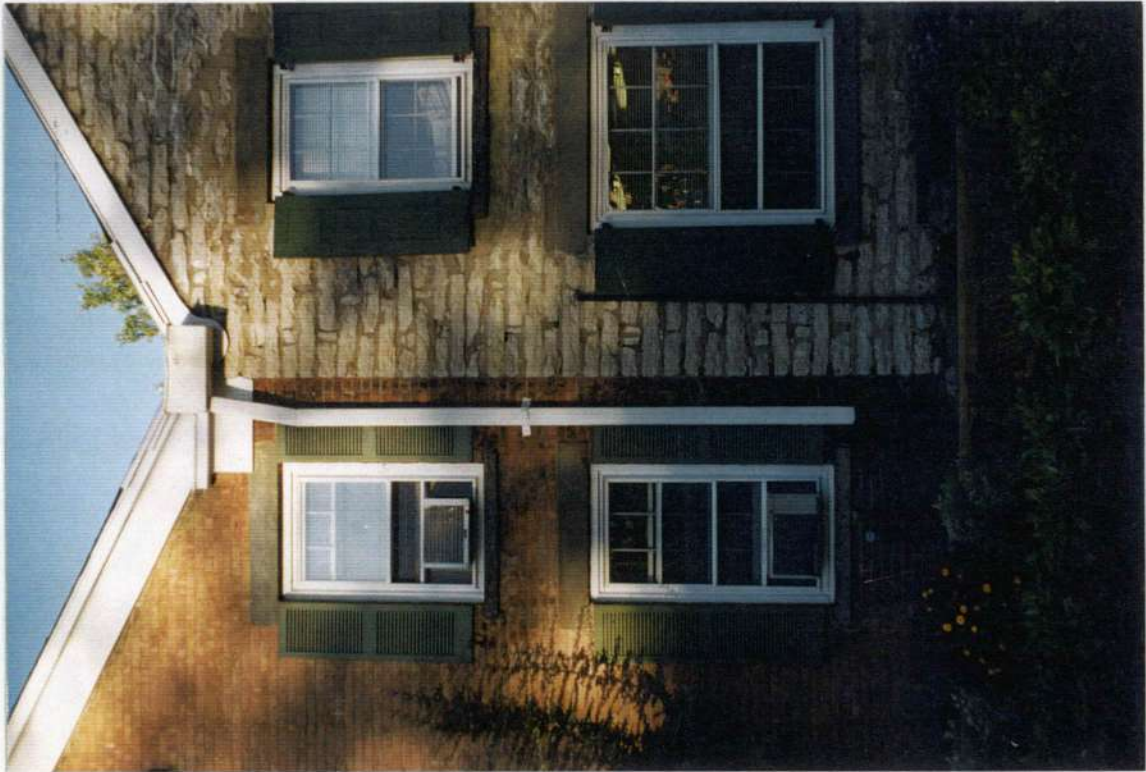
30. Joint between phase four stone and phase five brick addition. Note bluestone lintels and sills of phase five added over tops of phase four east façade windows; wider first floor window added phase five. Note wood shutters and plastic shutters of phase five.

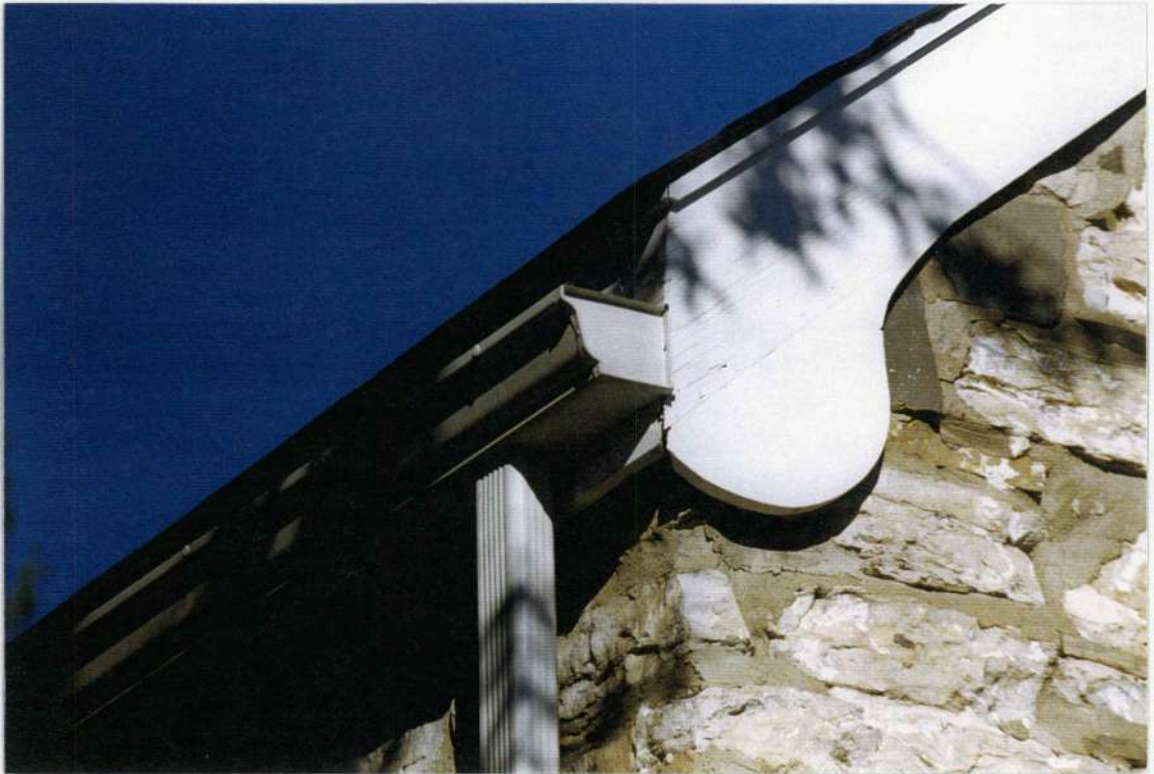
34. Ca. 1970 phase five replacement cornice and gutter detail to ca. 1850s gothic revival cornice.

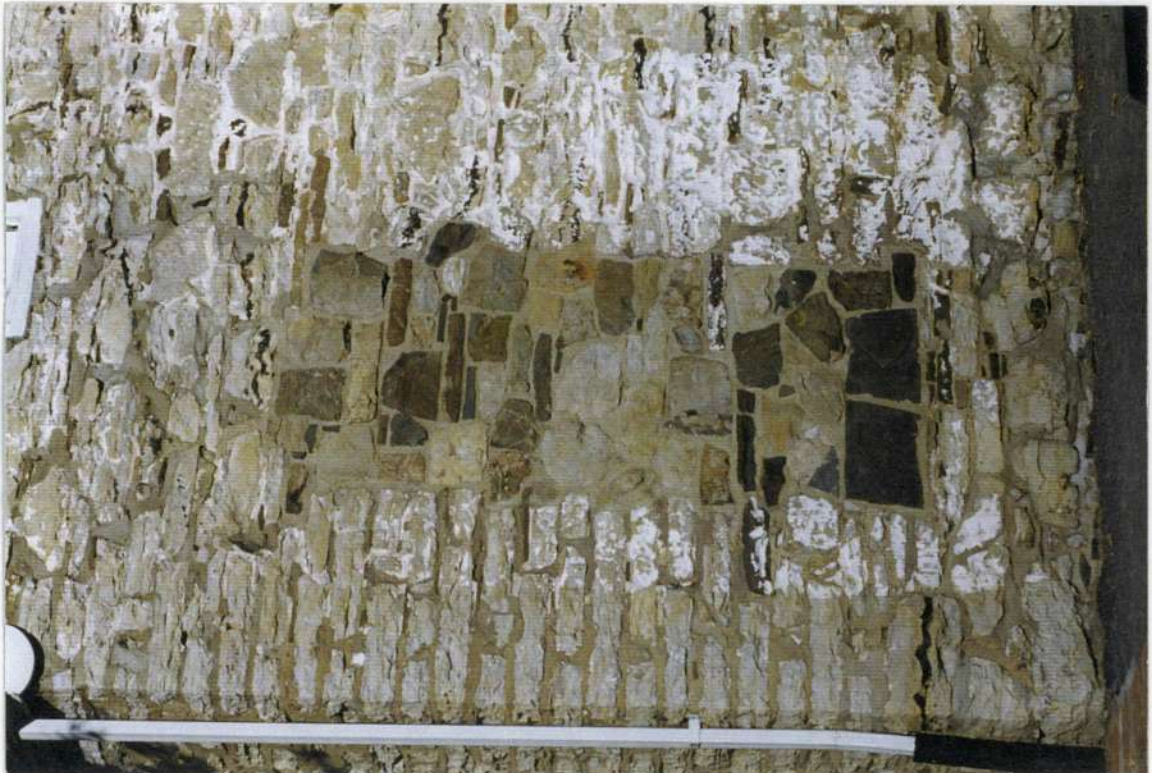
35. South phase two wall where door removed during phase five. This end of building had one story wood framed addition in late 1800s.

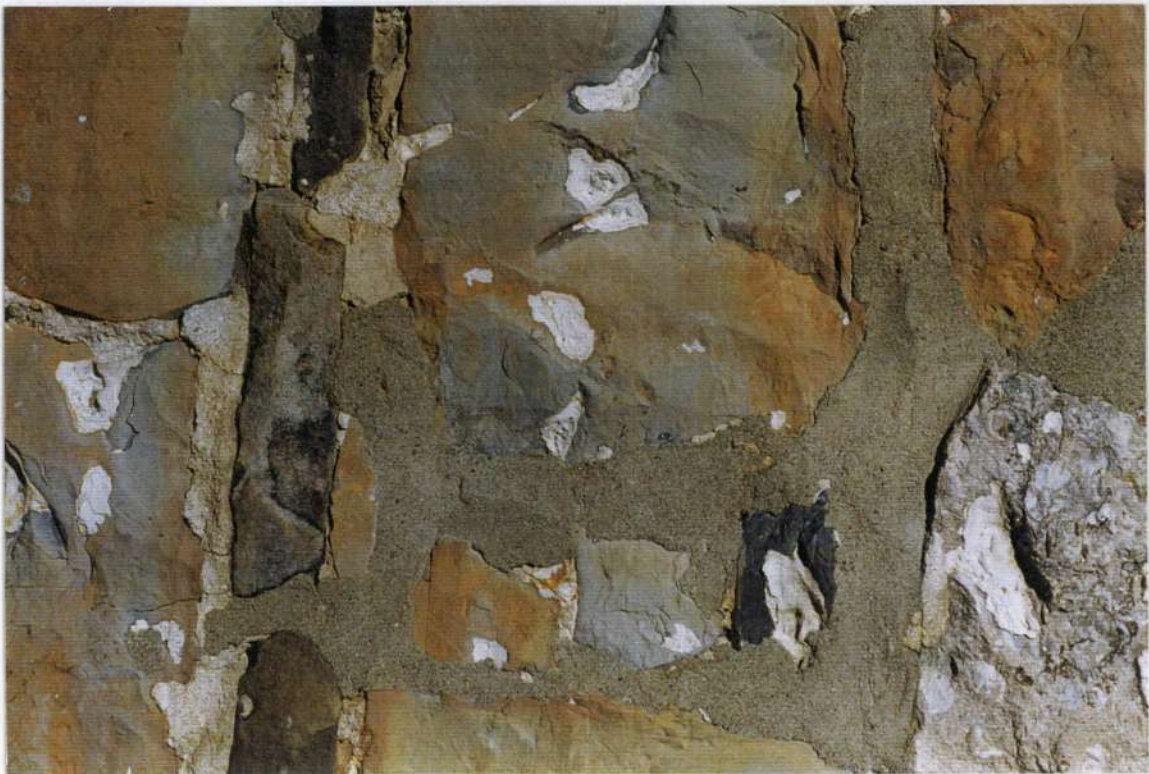
39. Phase three (phase five stone wall) with remains of whitewash finish.

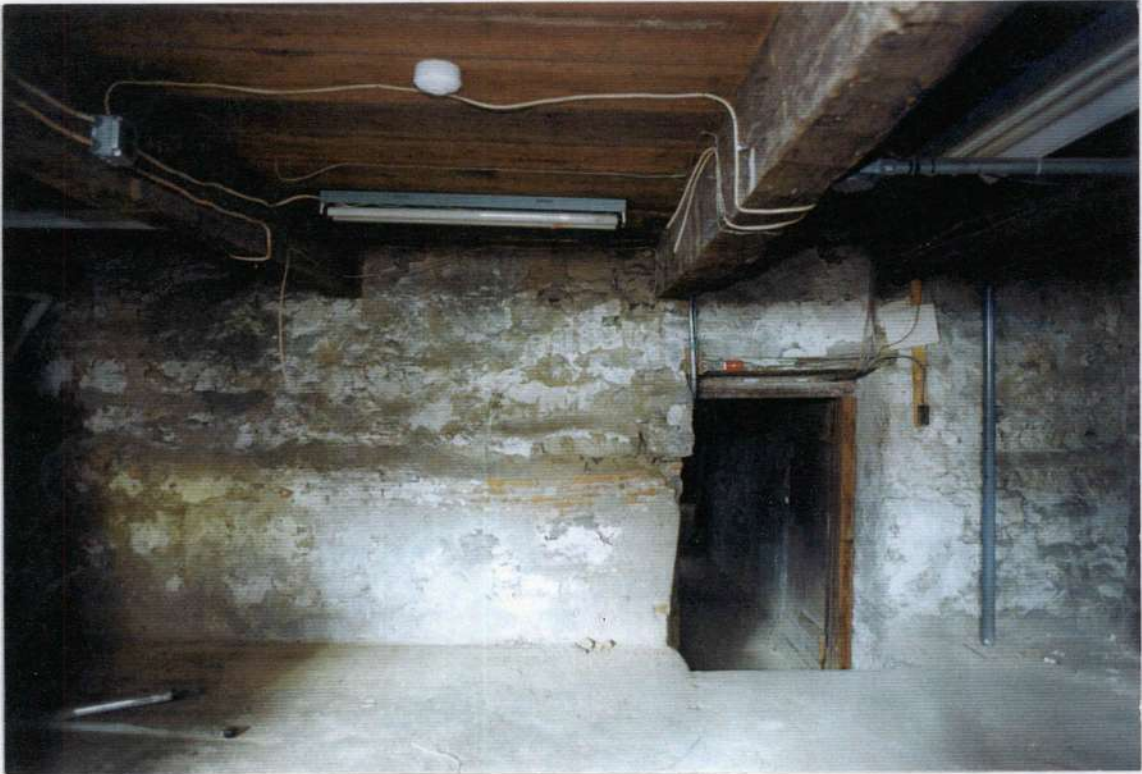
40. Space 001 east wall. Possible early arched brick Dutch fireplace first floor hearth support detail. Note wide board floor planks and hand hewn beams.

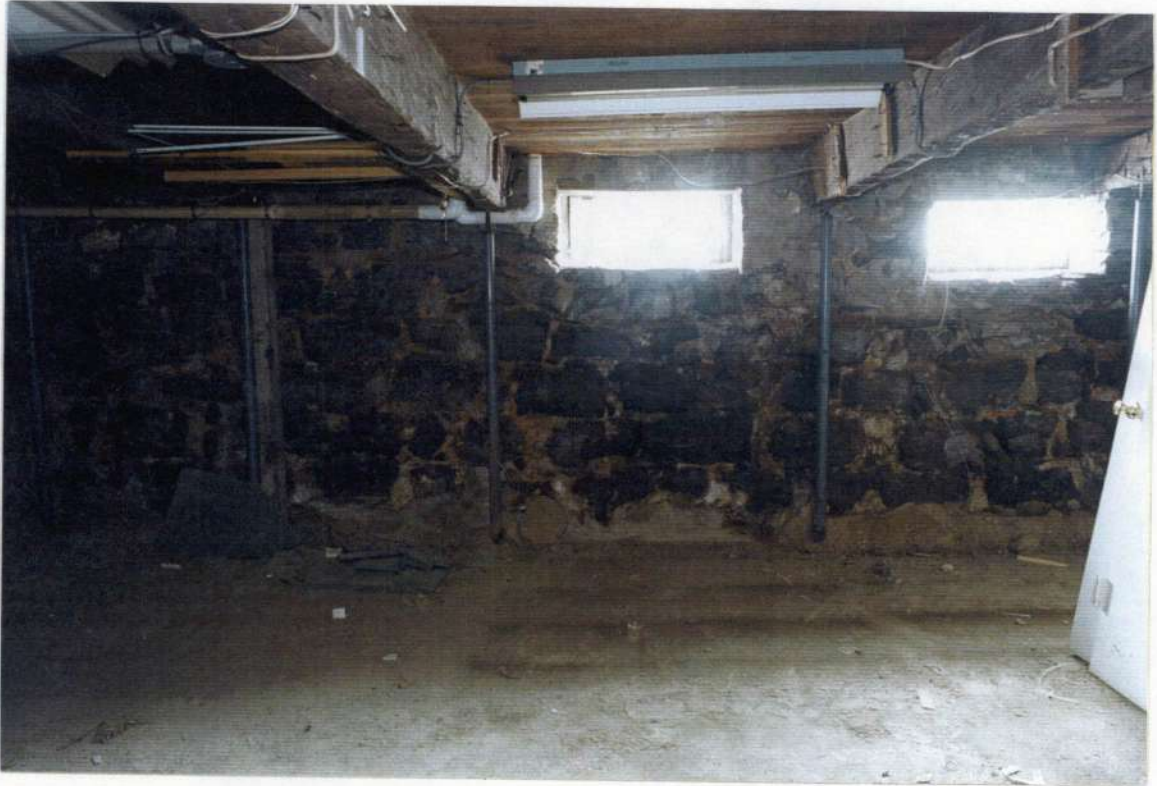
42. Space 001 west wall. Typical rubble foundation wall requiring repointing.

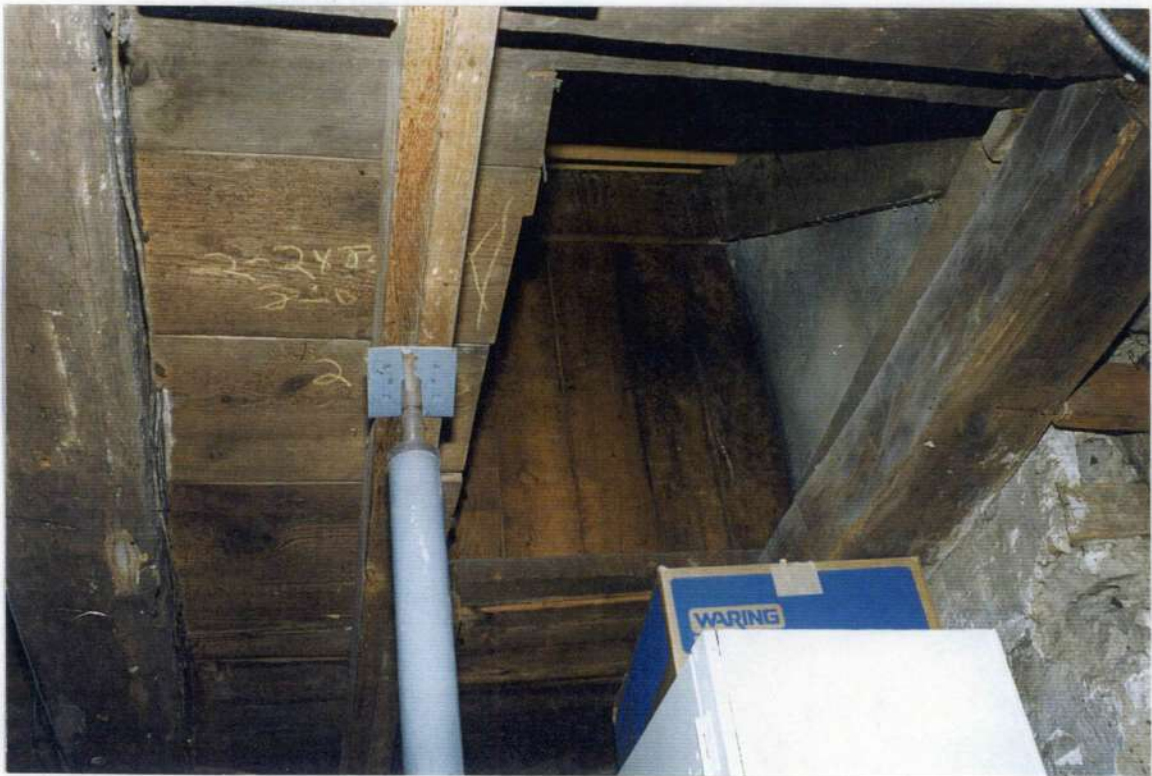
43. Space 001 southeast corner. Earlier stair opening to first floor (below present stair).

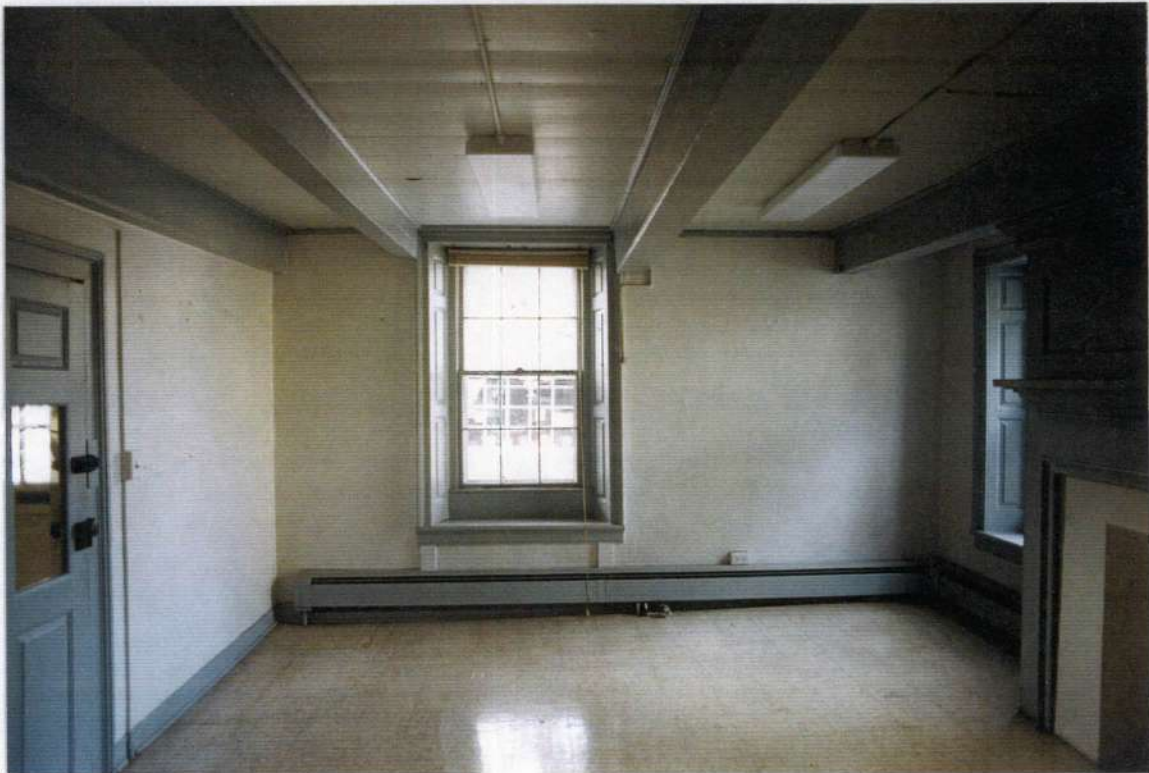
45. Space 101 west wall. Paneled window, beam ceiling with exposed wood planks. Note smaller beam to left of window. May be replacement beam.

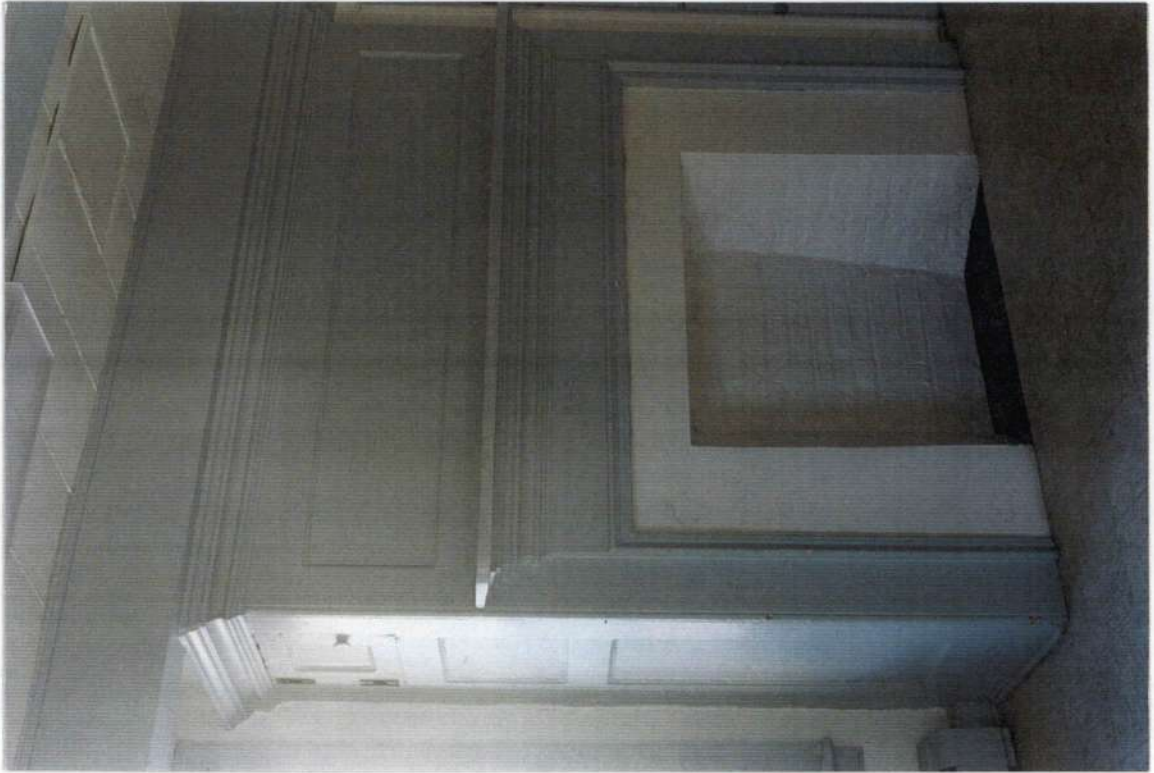
46. Space 101 north wall. Detail of English style paneled fireplace with heavy cornice moulding.

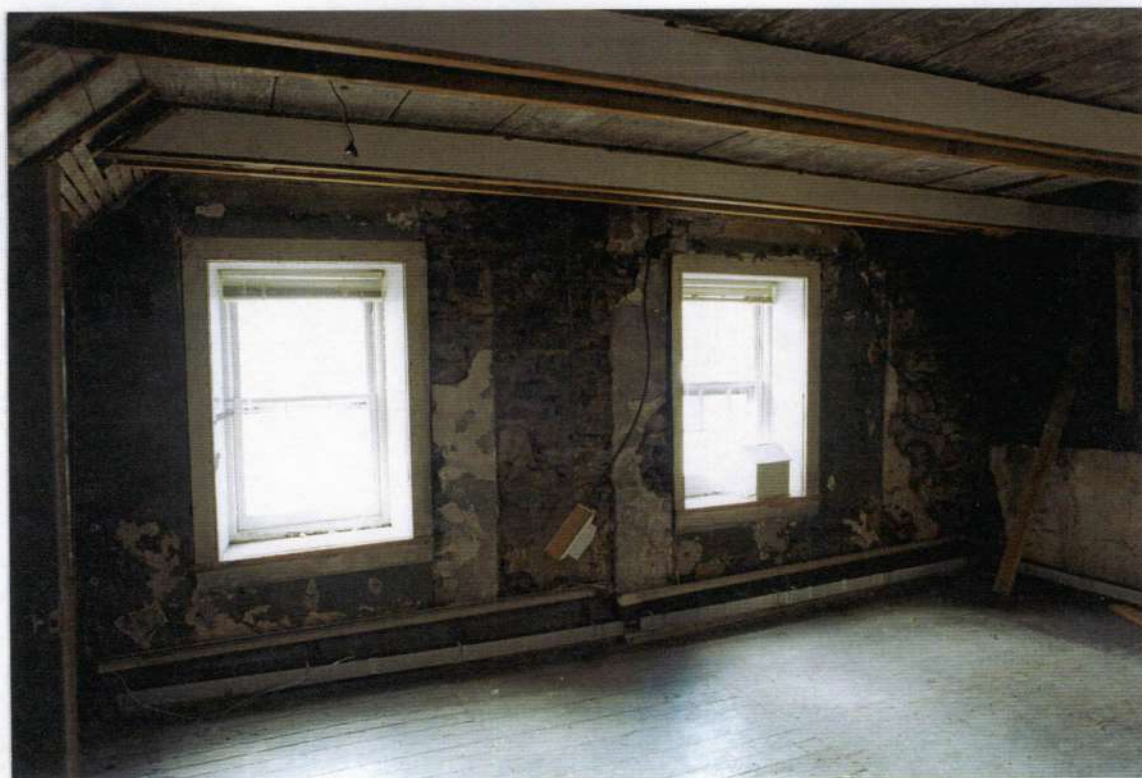
72. Space 201. North wall after removals. Note shadow where removed chimney was located; condition of knee wall juncture and stone gable end; altered collar beams.

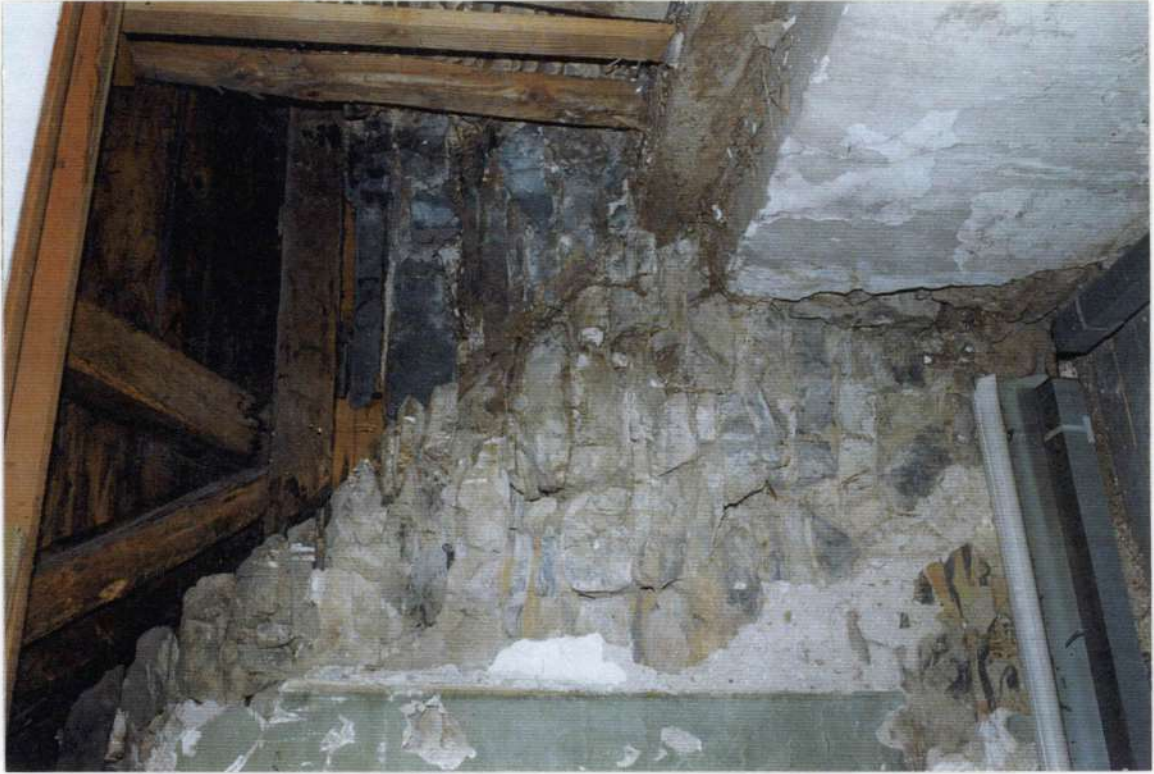
73. Detail: northeast corner of stone wall missing.

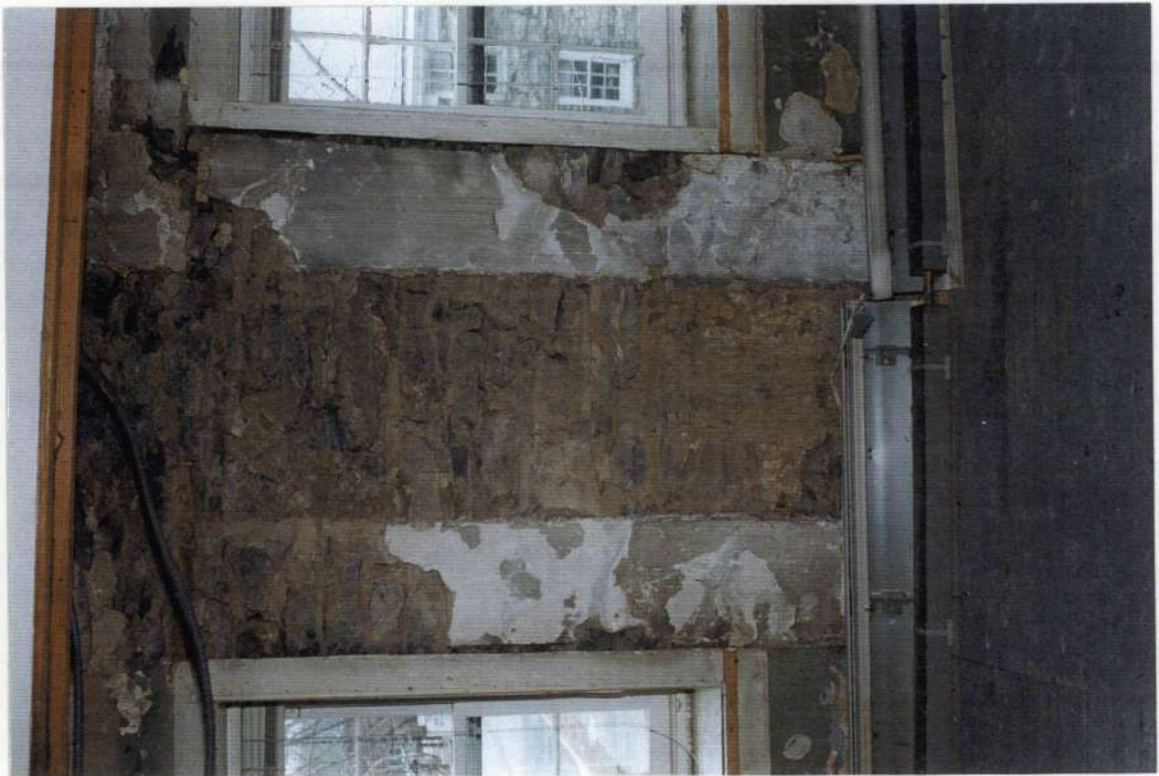
74. Detail: Shadow of removed chimney and chimney breast.

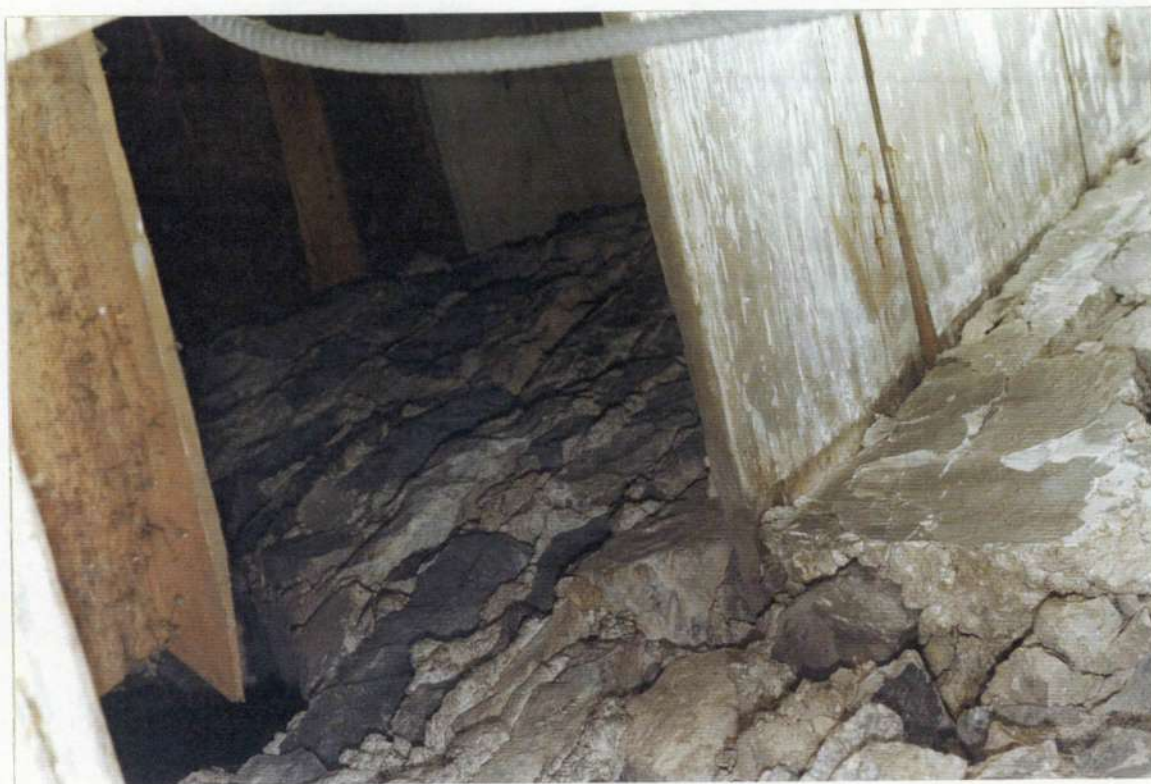
82. Detail: Space 201 north wall: early ceiling plank adjacent to removed chimney opening showing that stone gable end wall was built on top of planks at window height. Earlier wood framed upper gable end wall was removed and replaced with stone ca. 1850s.

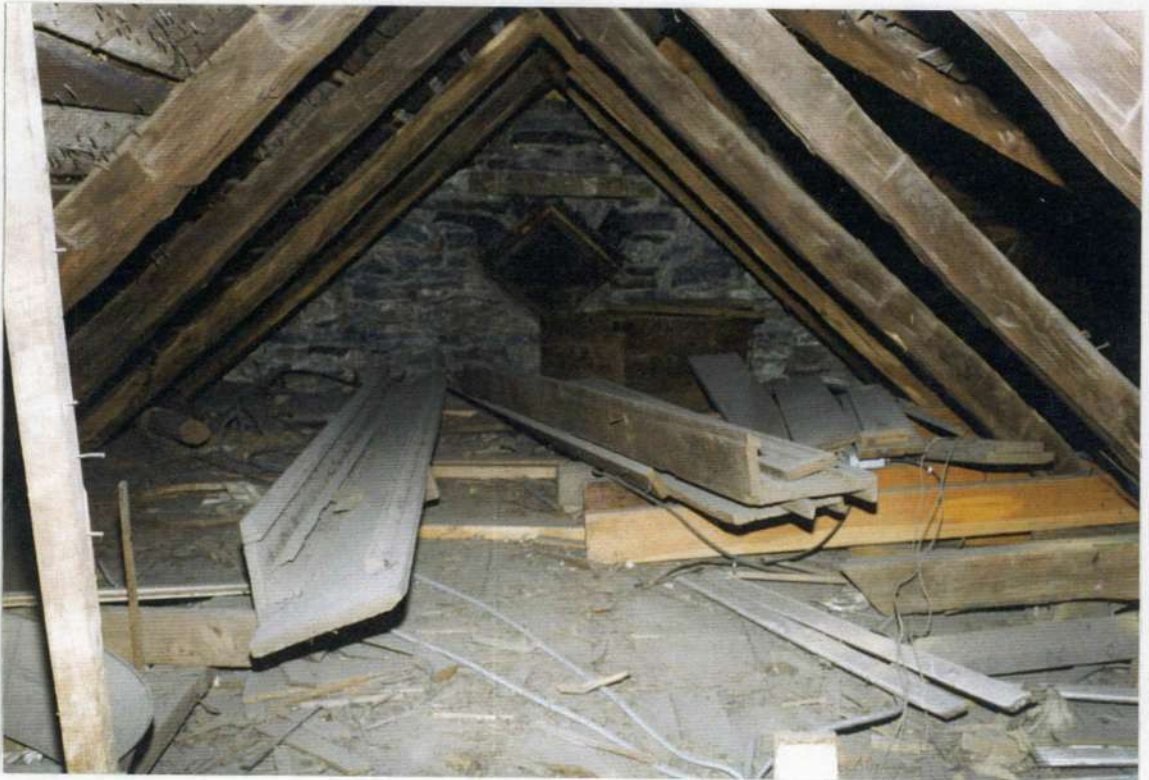
91. Attic of phase one over space 201 looking north. Note diamond detail in end wall where wood framed wall replaced. Brick chimney was removed in front of end wall with phase five renovation. Note remains of removed wood cornice board on attic floor.

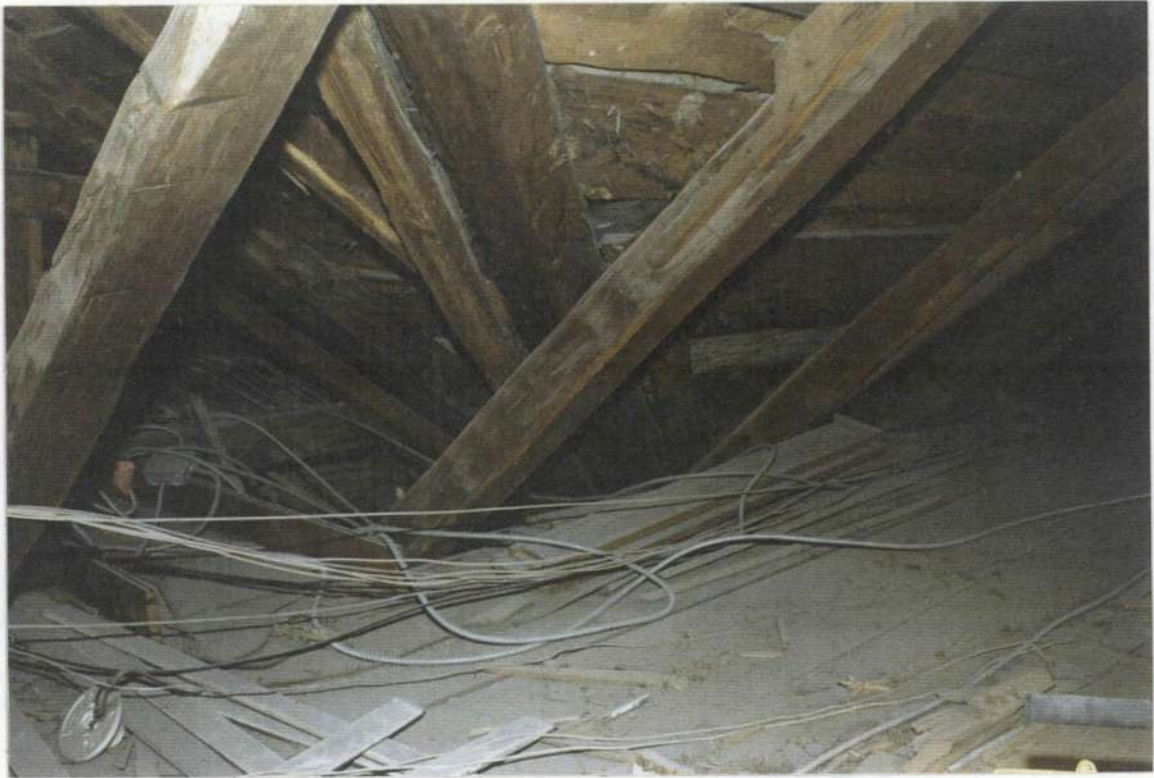
91a. Attic of phase one looking at phase four hand-hewn valley gutter and rafter built on top of phase one rafters.

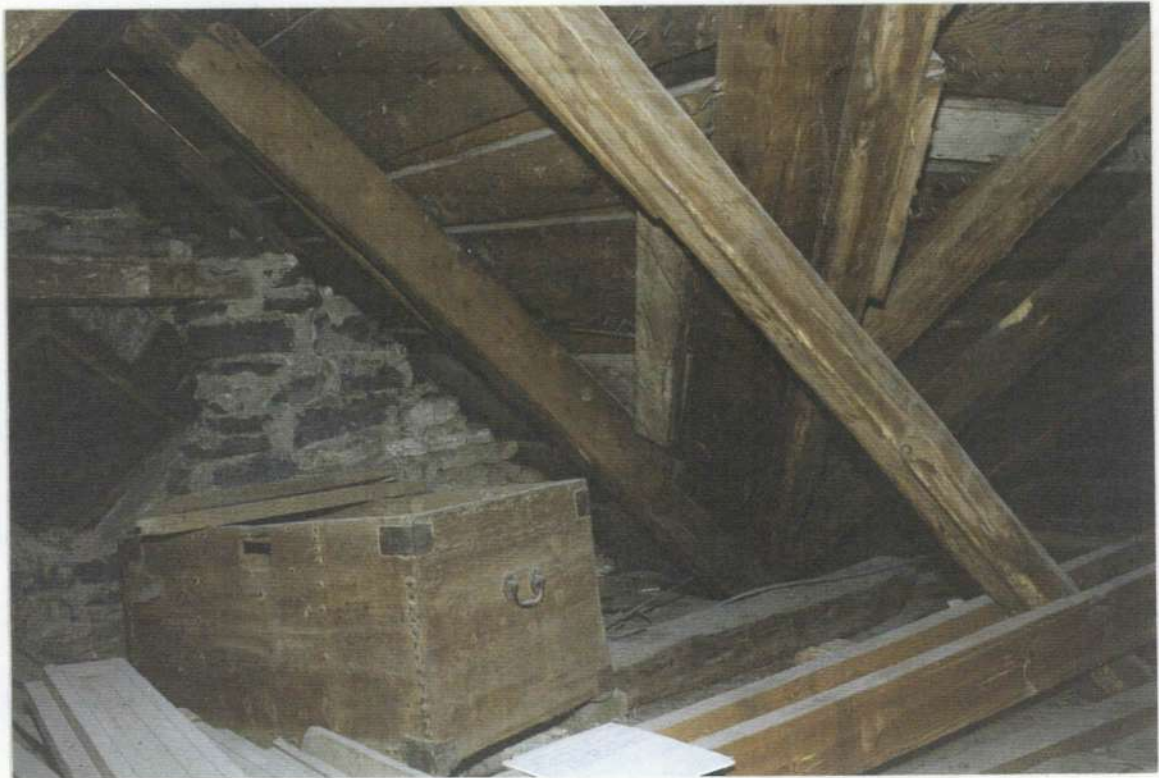
91b. Attic of phase one looking at phase four hand-hewn valley gutter and rafter built on top of phase one rafters. Note stone infill to north gable end.

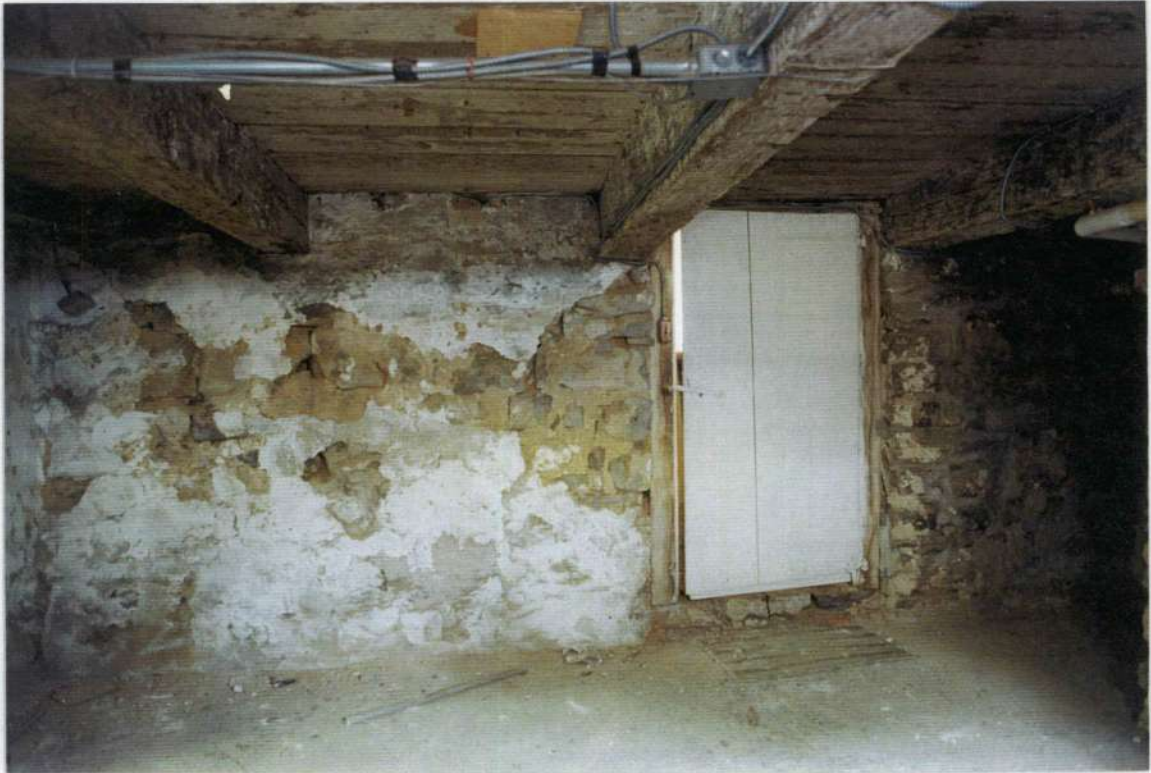
92. Space 002. East cellar rubble stone foundation wall with heavy oak framed Dutch detailed door; Steps up to first floor of phase three.

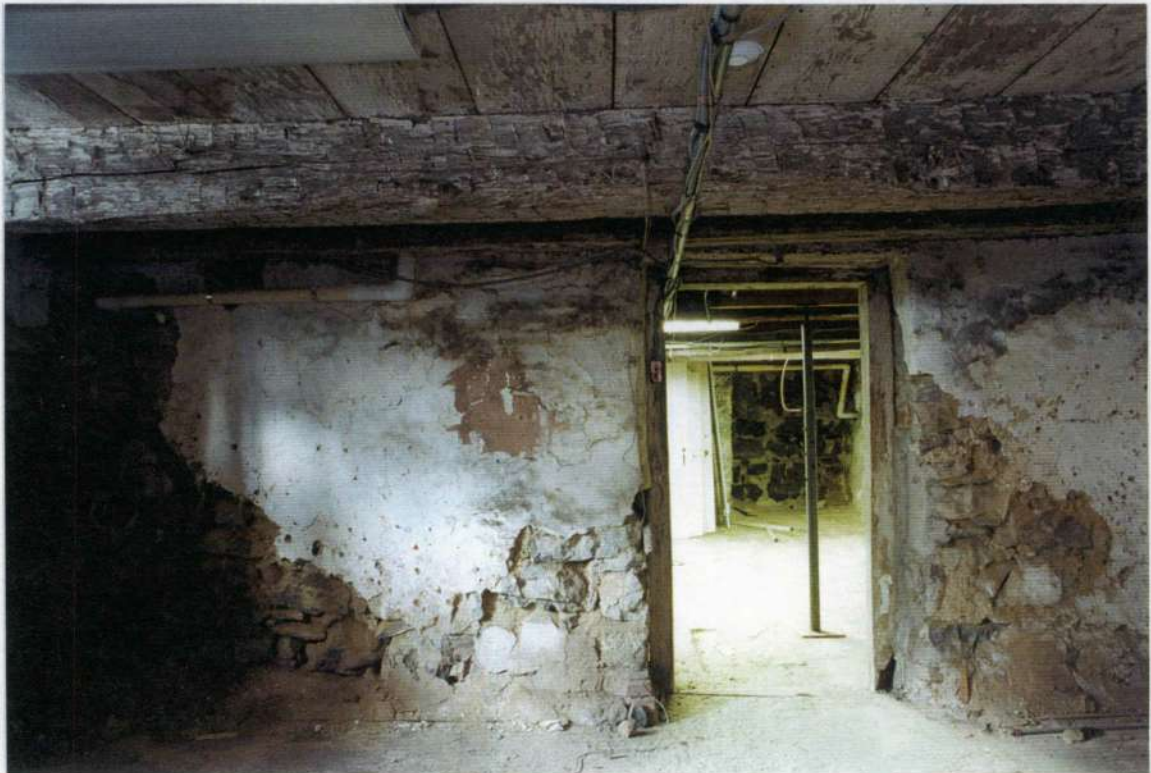
93. Space 002 north wall (exterior side of south phase one wall) with heavy oak door frame to space 001. Note early plaster on stone wall with paint finishes; wide board plank floor and hand hewn beams above.

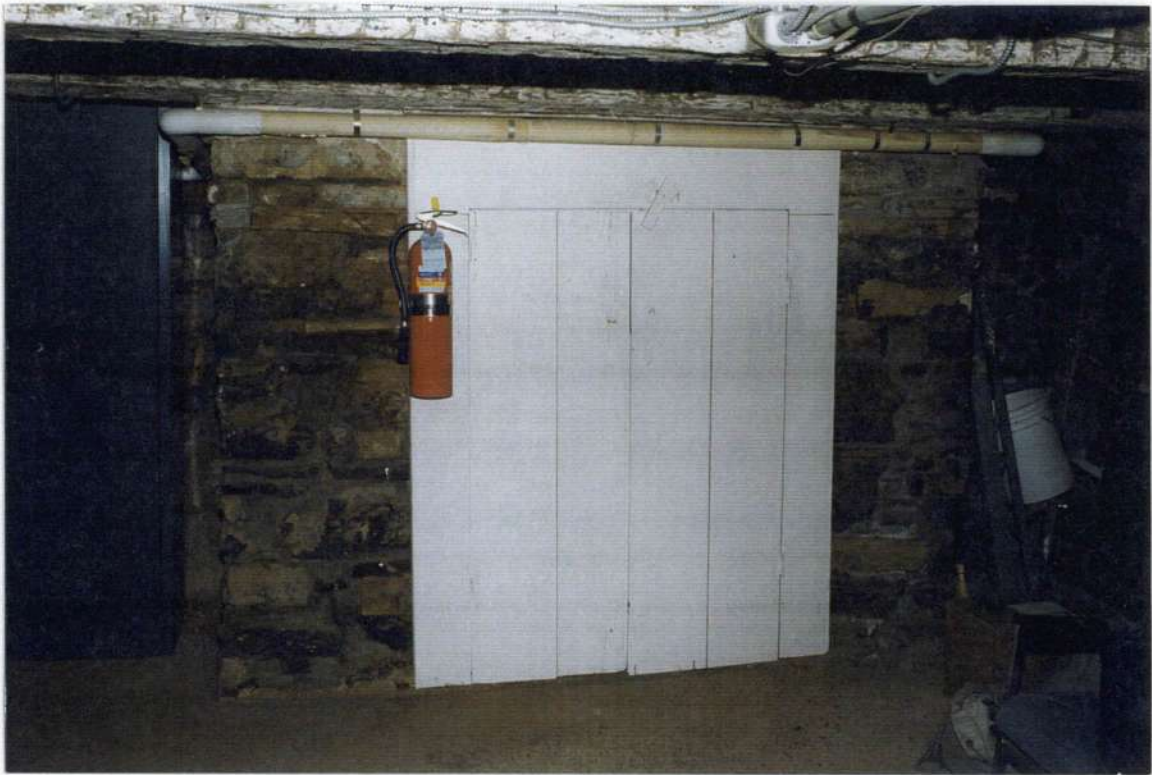
102. Space 002 south wall. Fireplace stone foundation and early plank doors over foundation opening.

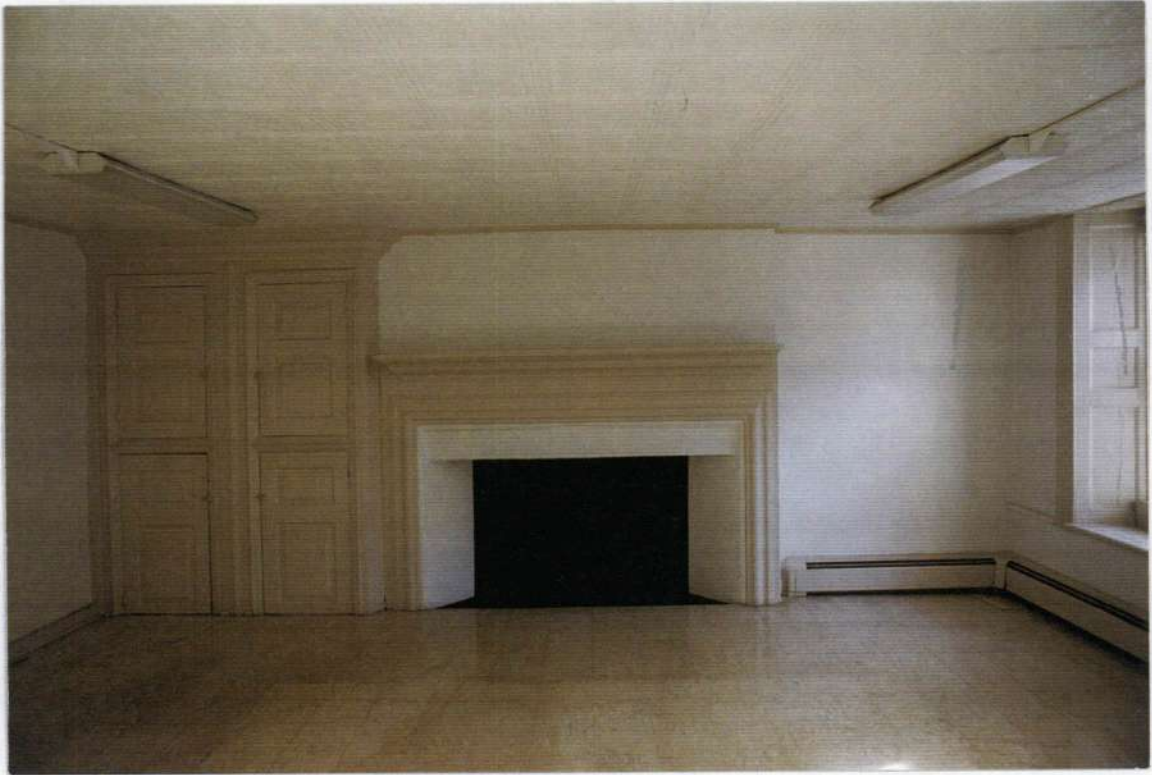
104. Space 103 South wall with early English style fireplace and built-in cupboards.

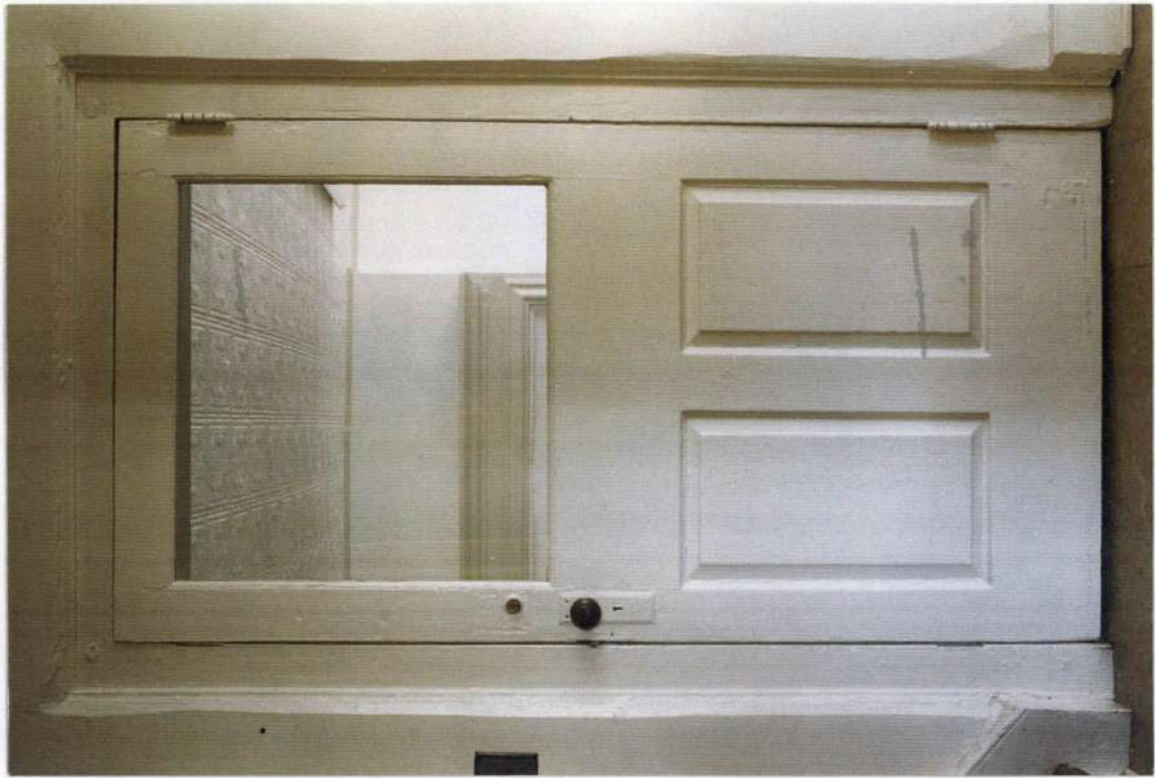
110. Detail: entry hall elevation of door to room 103. Raised panel with upper panels removed and replaced with glass.
