HISTORIC STRUCTURE REPORT

THE MATTHEWIS PERSEN HOUSE

A Case Study of the History of a House and the People who Lived There

Kenneth Hewes Barricklo Architect, P.C.
Kingston, New York

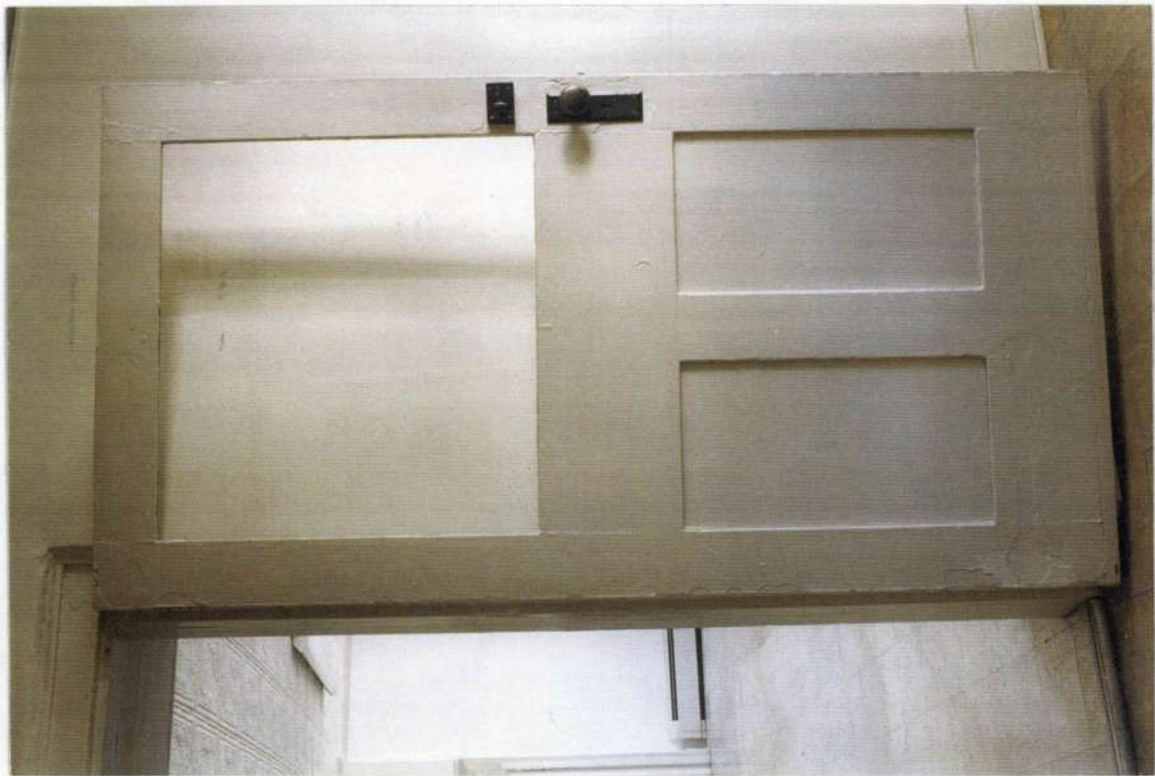
111. Detail: Space 103 side of door. Note shadows of Dutch pancake style strap hinge top and bottom. This door swing was reversed. The frame has pintel holes where door was hung on hall side of frame.

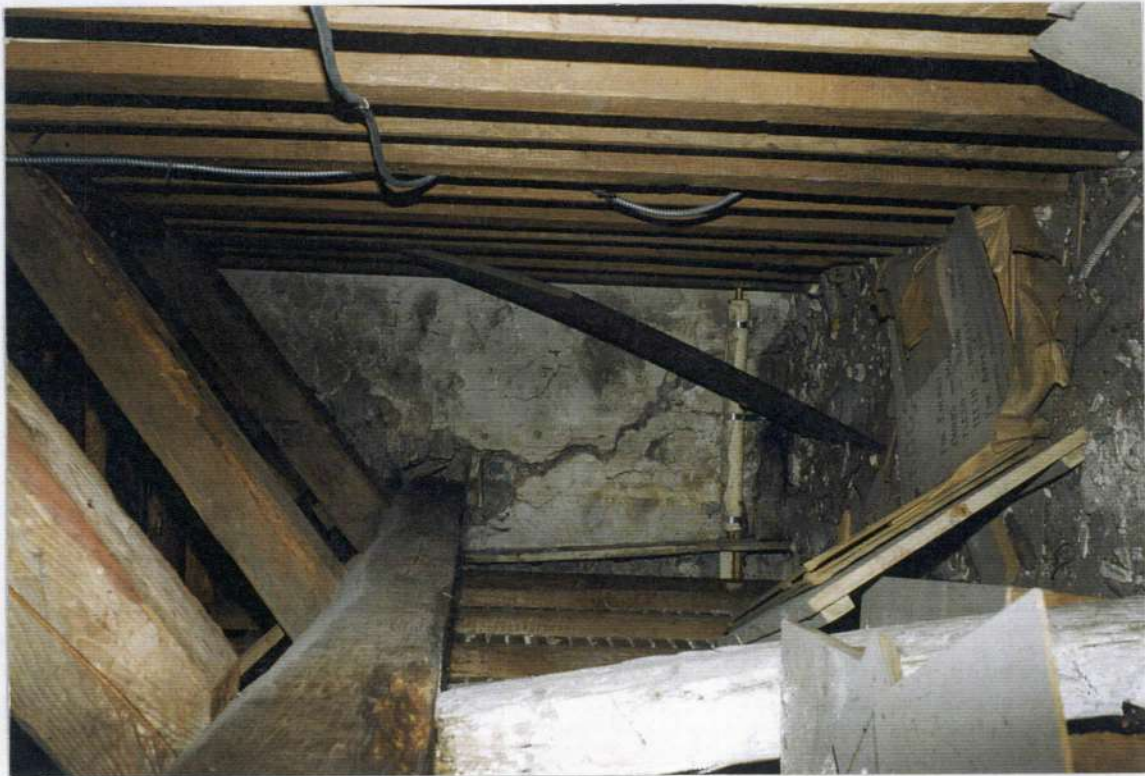
127. Space 204B looking south. Note cracked south stone wall of phase two; horizontal timber supported with vertical (sloping) posts down to top of first second floor beam at wall.

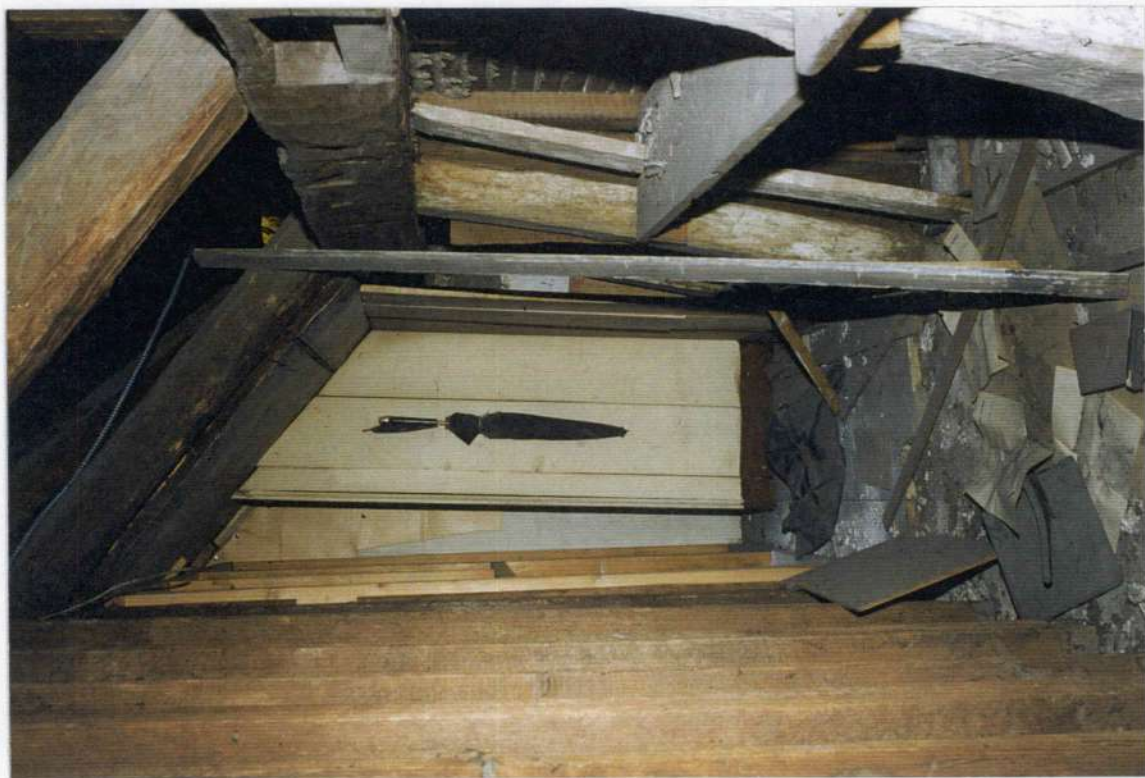
128. Space 204B looking north. Note that horizontal timber that supports the roof rafters has a mortise hole on the side, appears to be a recycled timber.

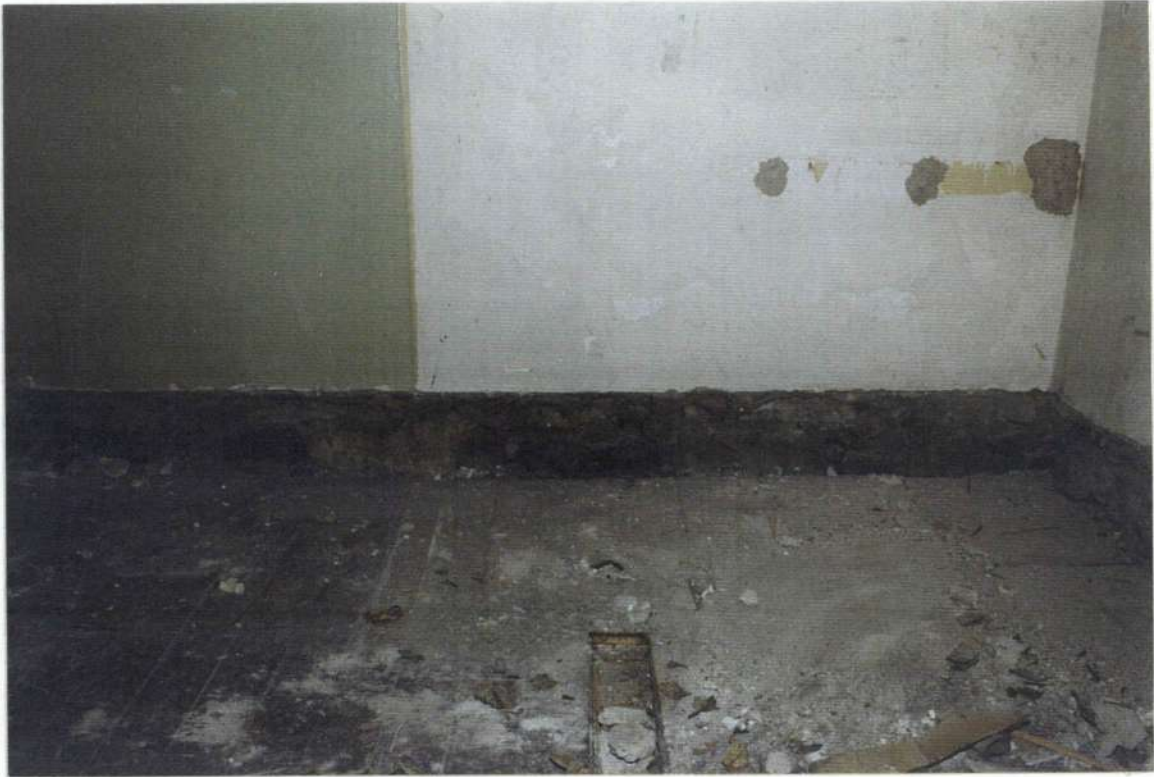
148g. Space 205 north wall. Baseboard removed. Burned stone, possible remains of burning in 1777.

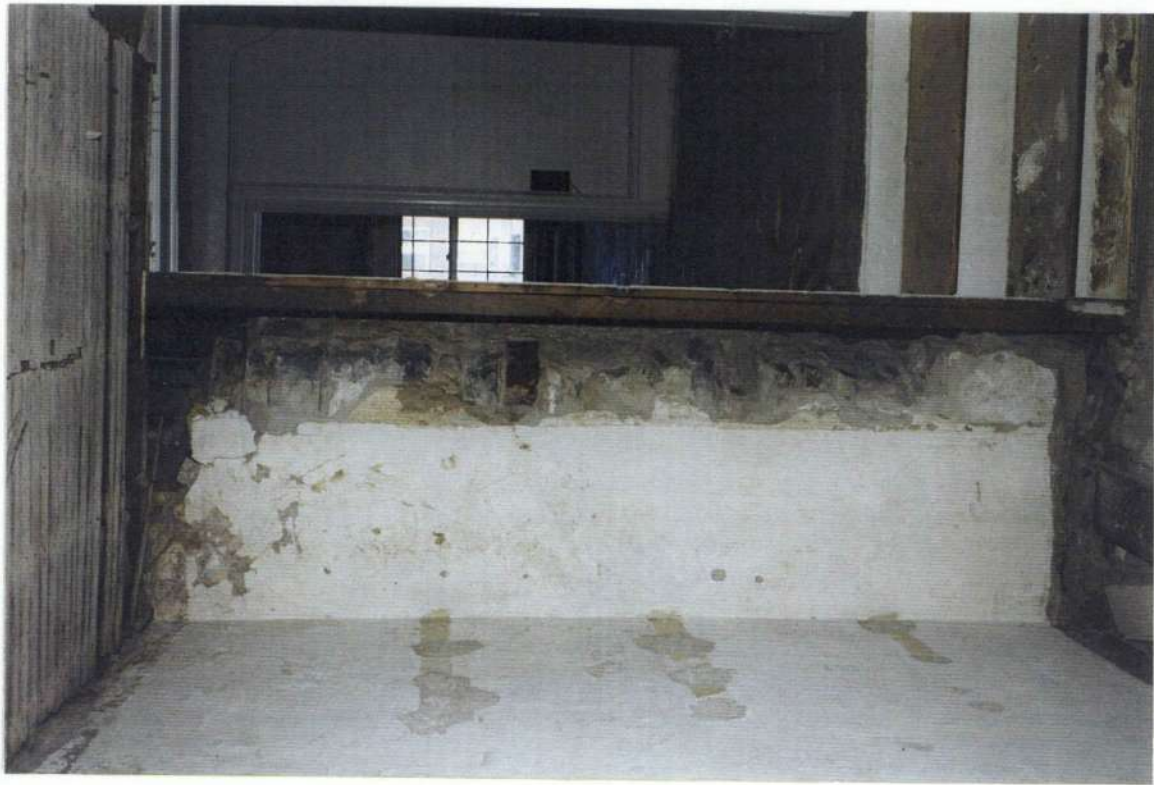
148h. Space 205 northeast corner of remains of phase four stone wall added to phase three east wall.

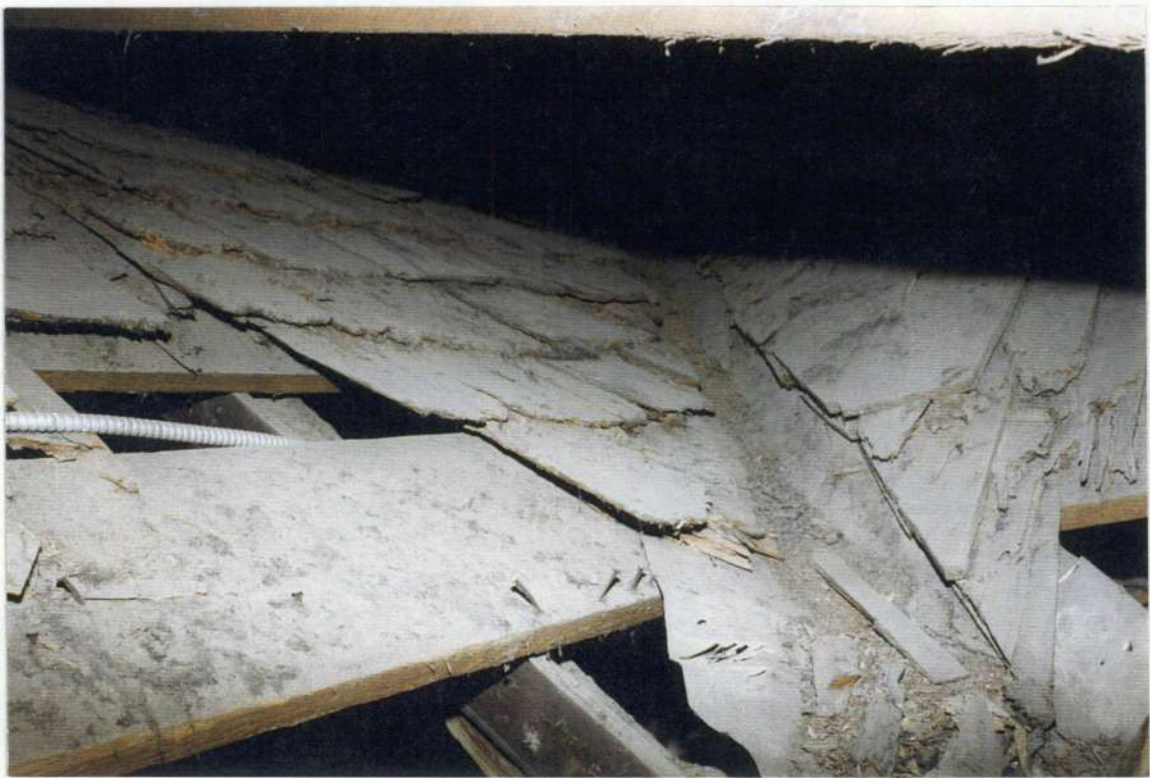
152. Hand hewn valley gutter (covered with tin) at valley intersection of phase three roof to phase two. There is a similar condition where phase four frames into phase one. All roof framing appears to be from 1778 period.

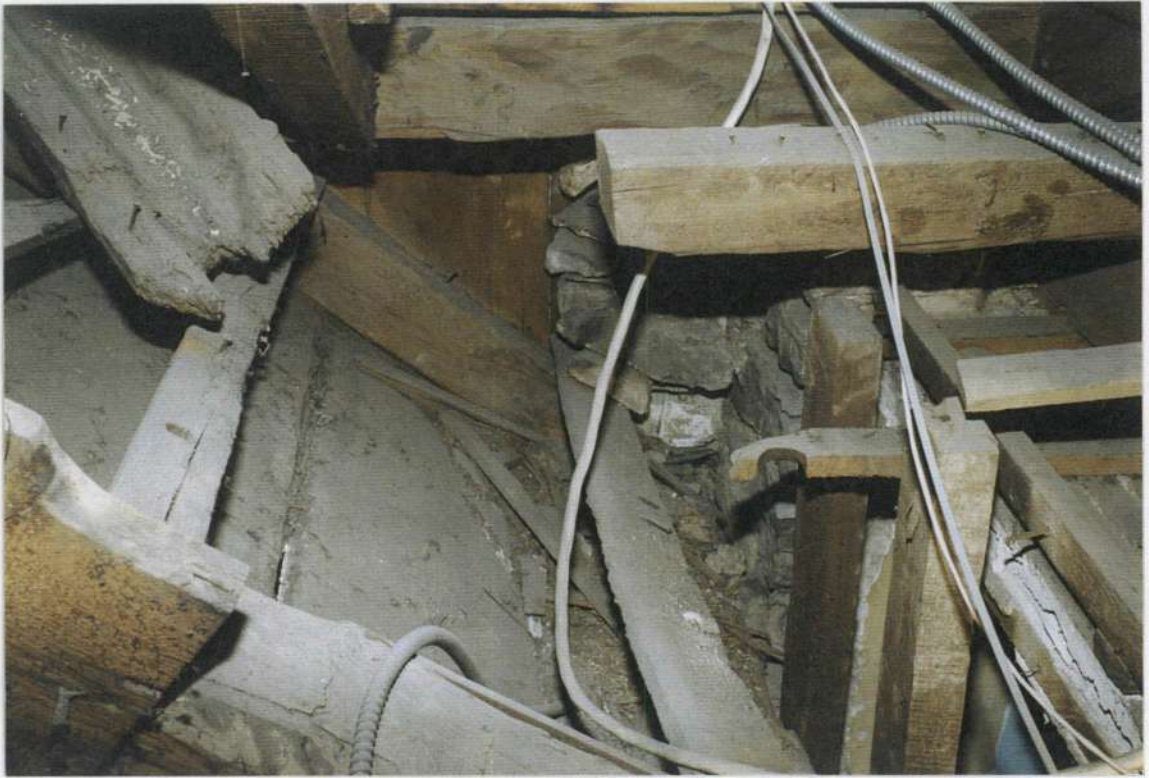
152a. Hand hewn valley gutter of phase four, upper left, built on top of phase one roof. Note end of phase four south stone wall to the right. View looking north.

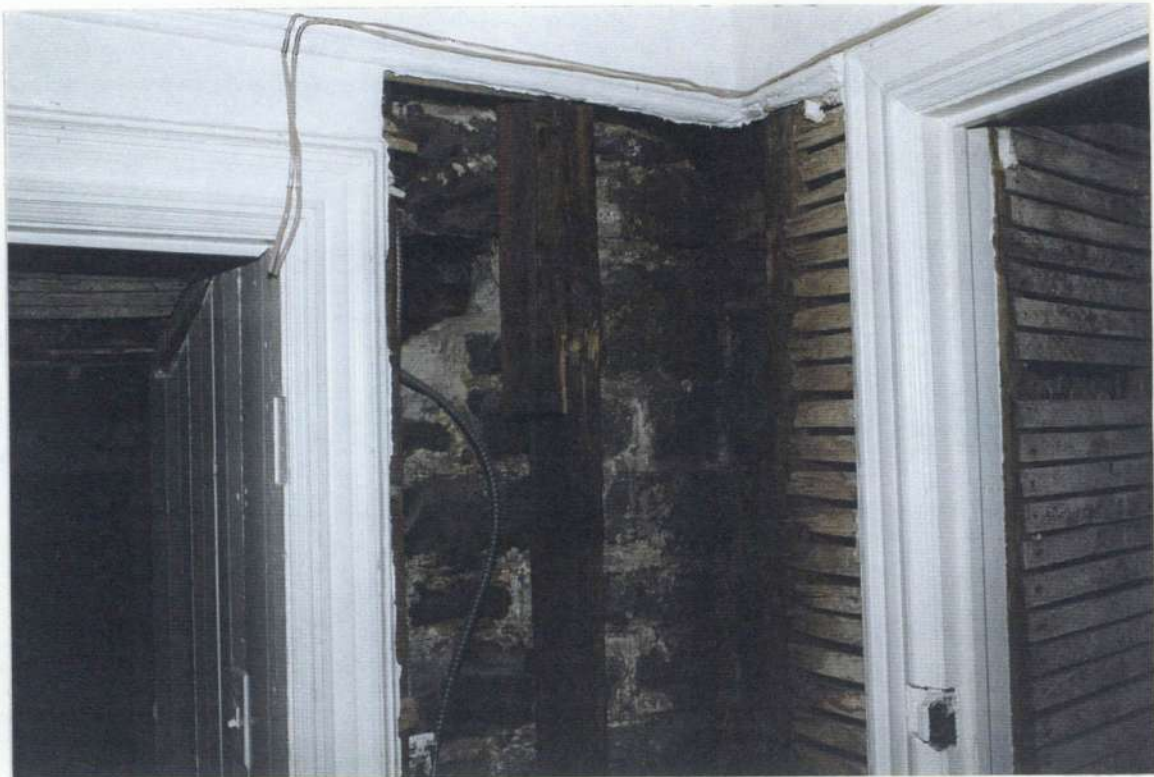
153b. Northeast corner of phase four stone wall added to east wall of phase three. As seen from phase five. This is the junction at the phase four south wall.

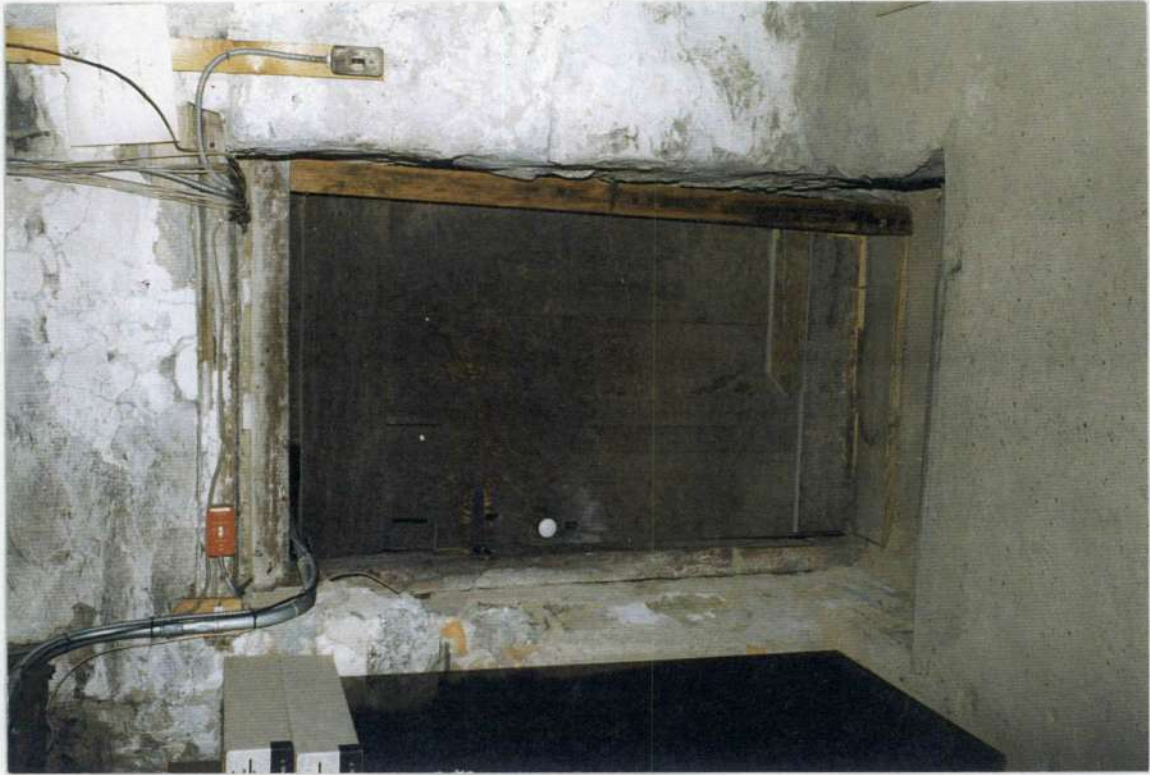
154. Cellar door between spaces 001 and 003 as seen from space 001. Door frame mortise and tenon pegged framed.

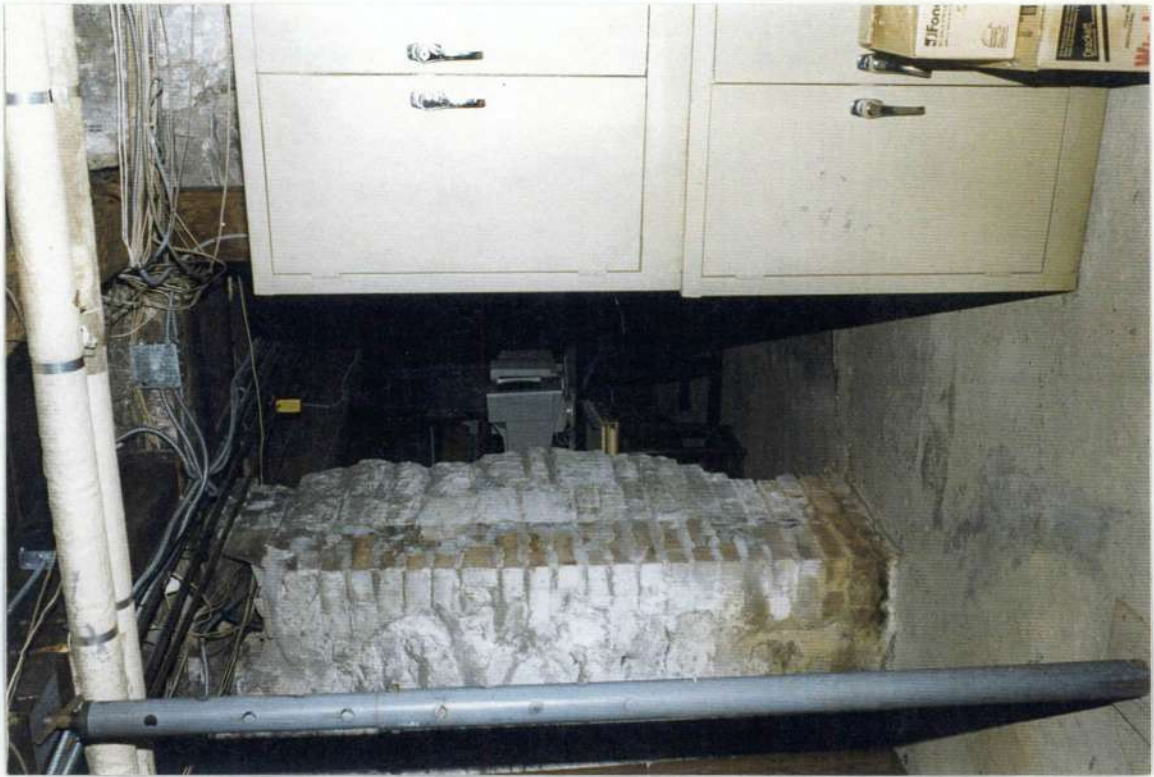
156. Opening in phase four foundation wall from space 003 to phase five. Note bricked opening and rough exterior side foundation wall of phase four.

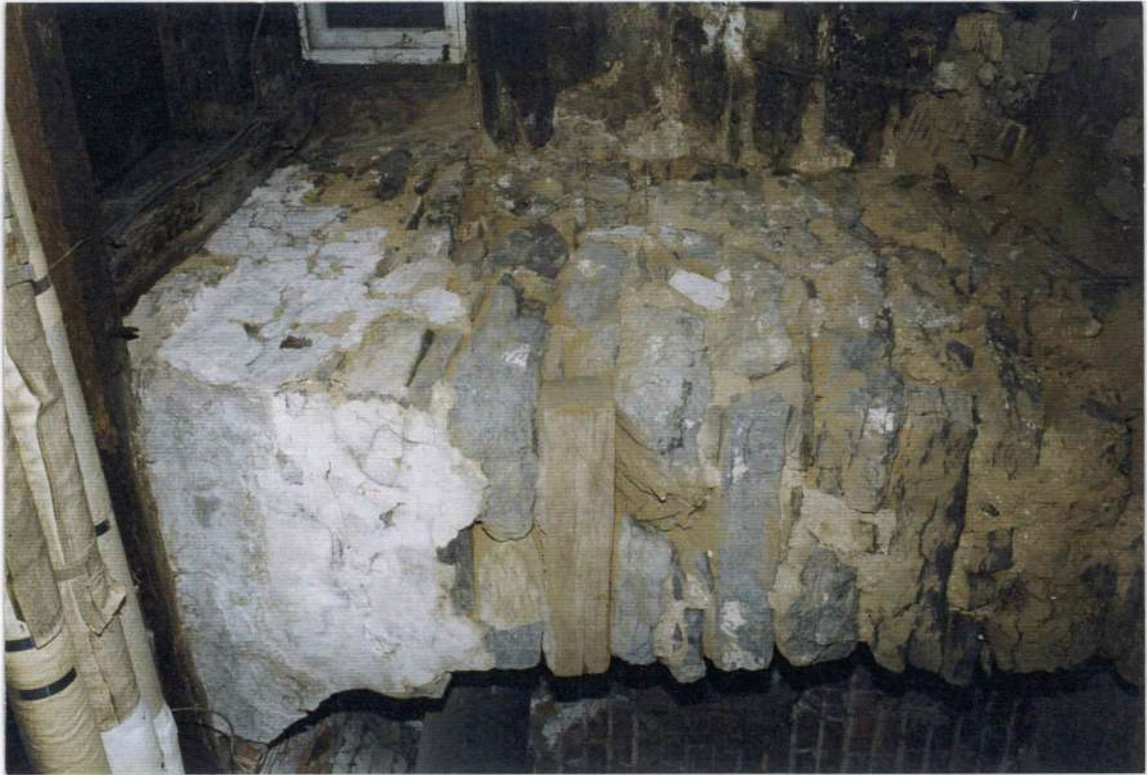
158. Space 003 east wall fireplace foundation.

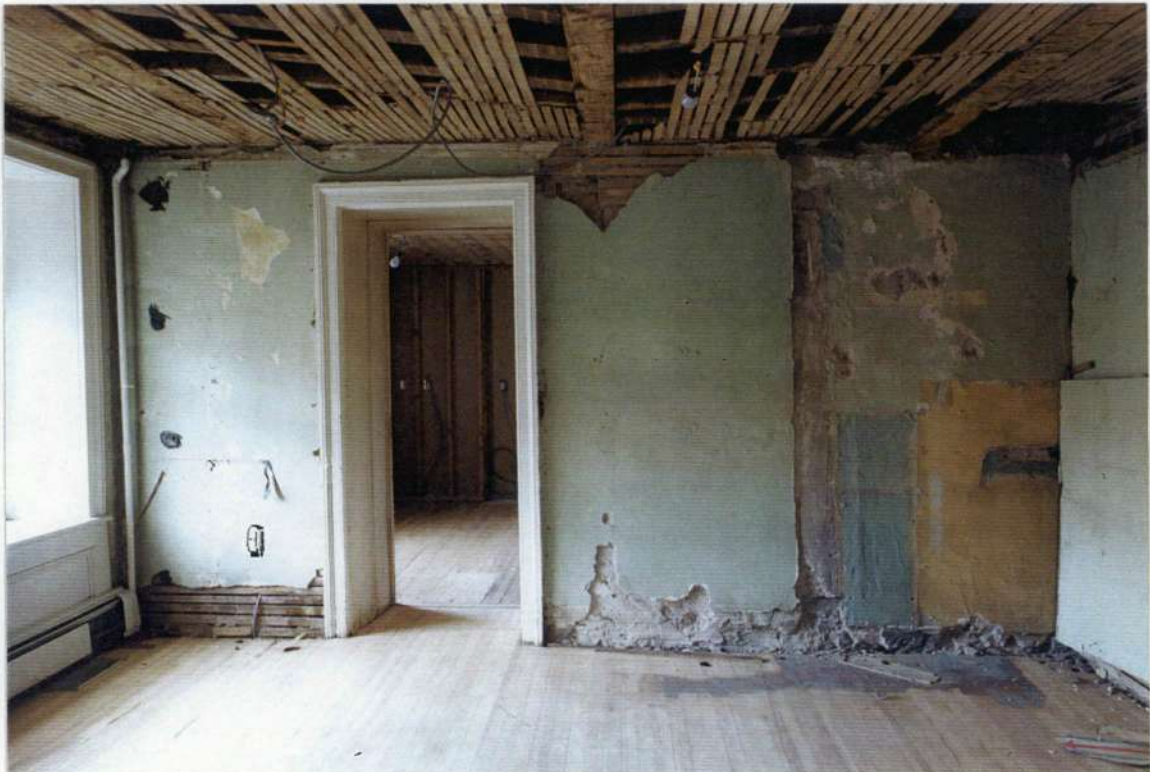
188. Space 109 south wall after removals. Note wood lath and plaster ceiling, cut beams, exposed interior side of phase four stone wall plastered (right side), and wood lath and plaster over stone wall (left side) indicating possible stone wall deterioration.

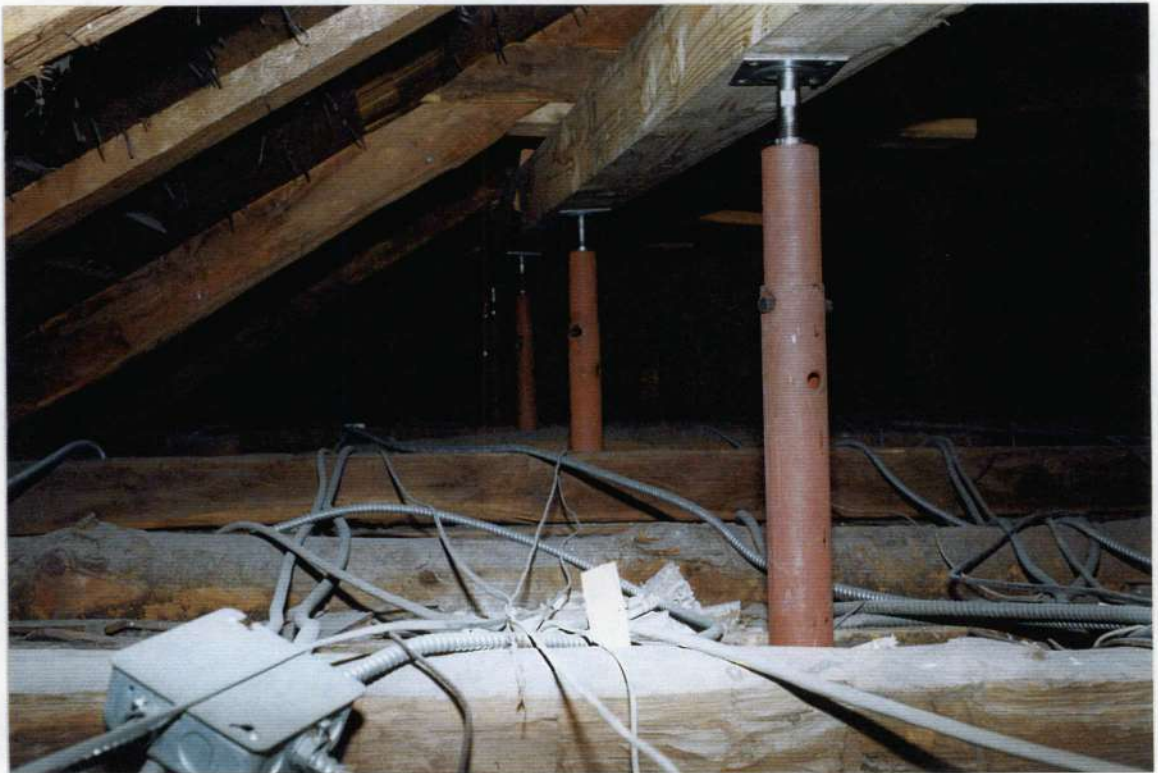
222. Attic over space 208 looking west. Note emergency shoring for failing roof along east stone wall.
